**RE: Asbestos Report for 25 Michlin Street, Moorooka Qld 4105**

## Report on Asbestos Containing Materials in the Workplace

**Site name:** 25 Michlin Street, Moorooka Qld 4105

**Date of Inspection:** 09/05/2022.

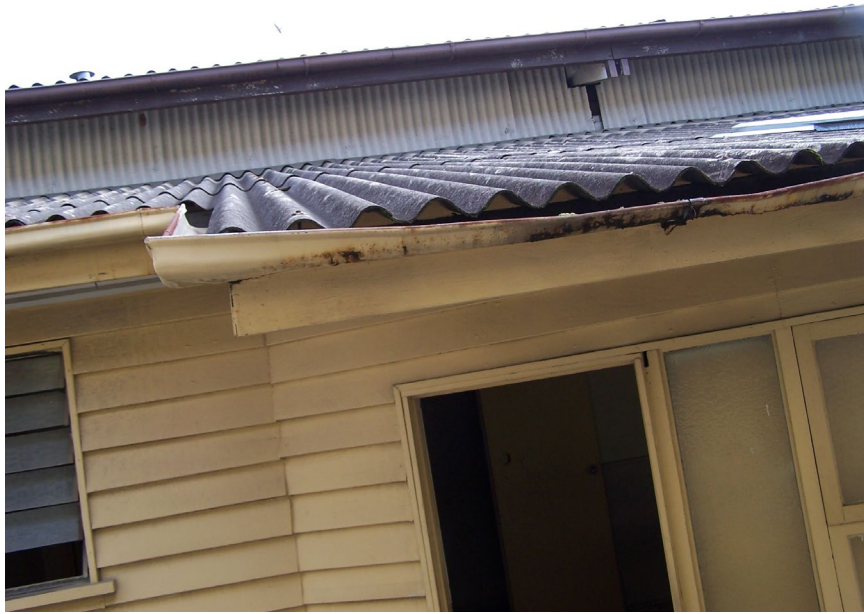
**Photo No: 94**

**Roof – Roofing**

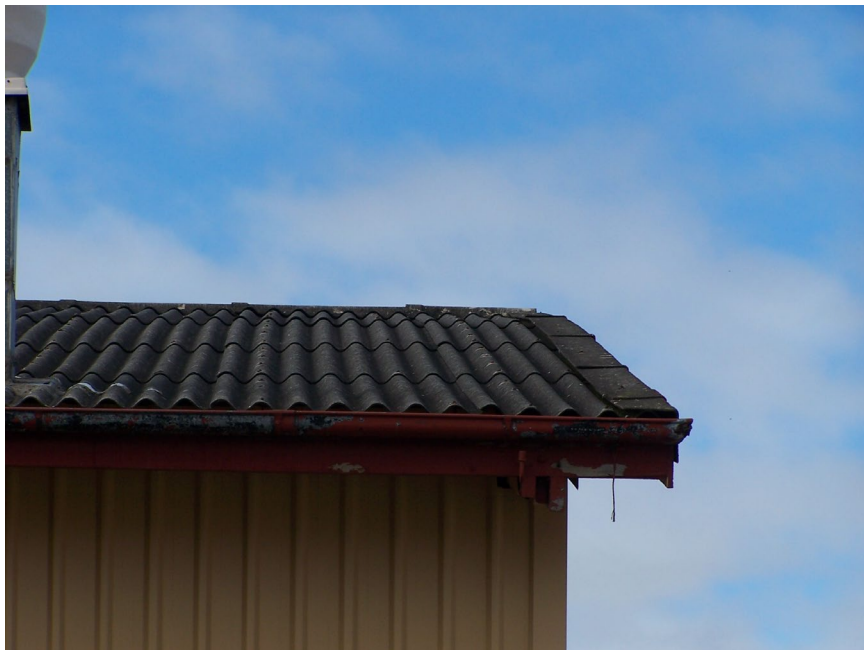
**Photo No: 95**

| Asbestos Containing Materials Register | | | | | | | | | | | | No Asbestos Detected | | | Areas with no Access | | |
|--|---|---|---|---|---|---|---|---|---|---|---|---|---|---|---|---|---|
| | Roof | Roofing | RS | 600 | sm | Super Six | P | B | F | R | R | X | E | | 95 | | Consider reroof |
| | Roof | Ridge/Barge | RS | | | Formed A/C Sheet | P | B | F | R | R | X | E | | 95 | | Consider reroof |

**Roof – Ridge/Barge**

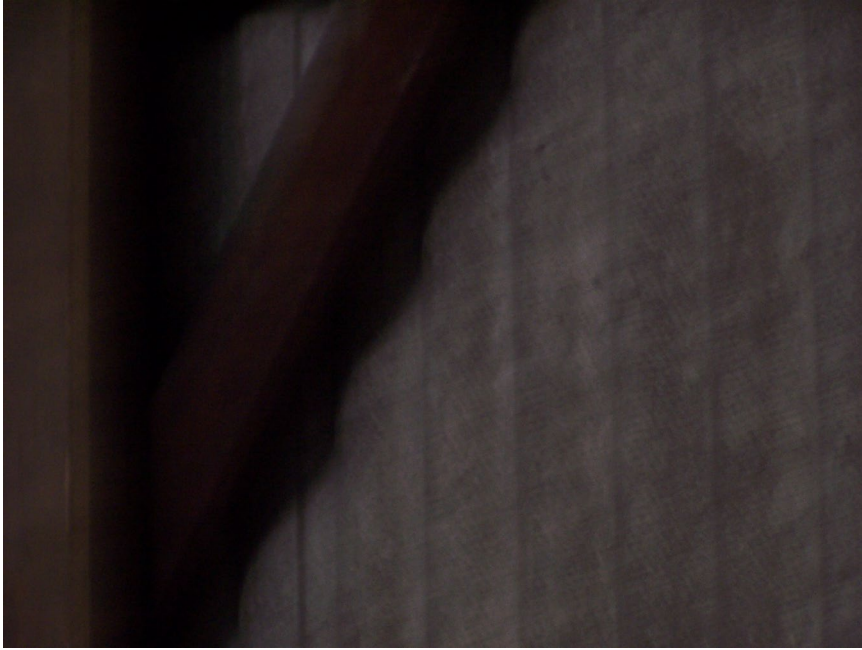
**Photo No: 96**

| Asbestos Containing Materials Register | | | | | | | | | | | | No Asbestos Detected | | | Areas with no Access | | |
|--|---|---|---|---|---|---|---|---|---|---|---|---|---|---|---|---|---|
| | Unit 10 Rear Wall | Wall Lining | P | 18 | | Mini Orb | P | B | F | R | R | X | | | 96 | | now covered |

**Unit 10 Rea Wall – Wall Lining**

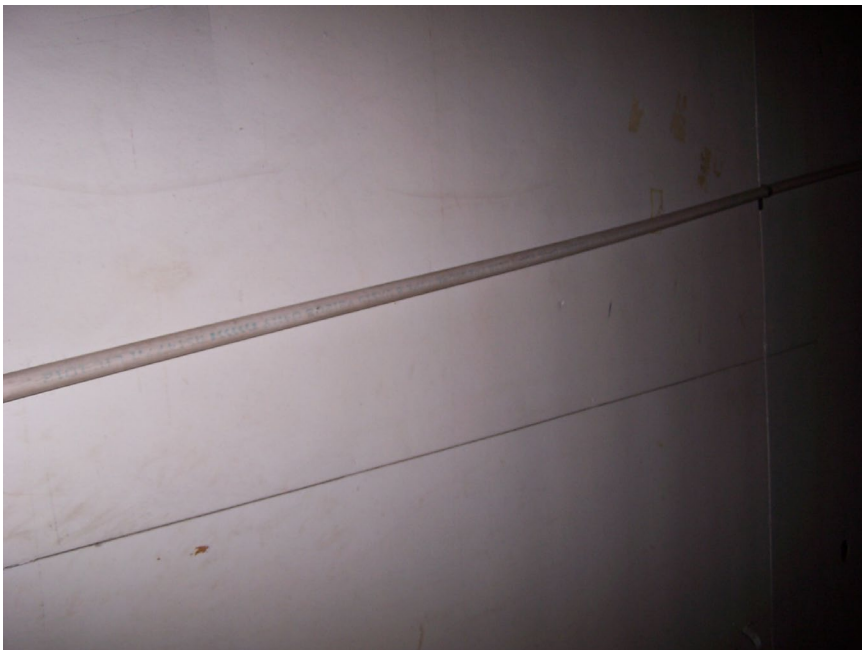
**Photo No: 84**

| Asbestos Containing Materials Register | | | | | | | | | | | | No Asbestos Detected | | | Areas with no Access | | |
|--|---|---|---|---|---|---|---|---|---|---|---|---|---|---|---|---|---|
| | Café Hallway | Wall Lining | P | 12 | | A/C Sheet | P | B | G | R | R | X | | | 84 | | part removed |

**Café Hallway – Wall Lining**

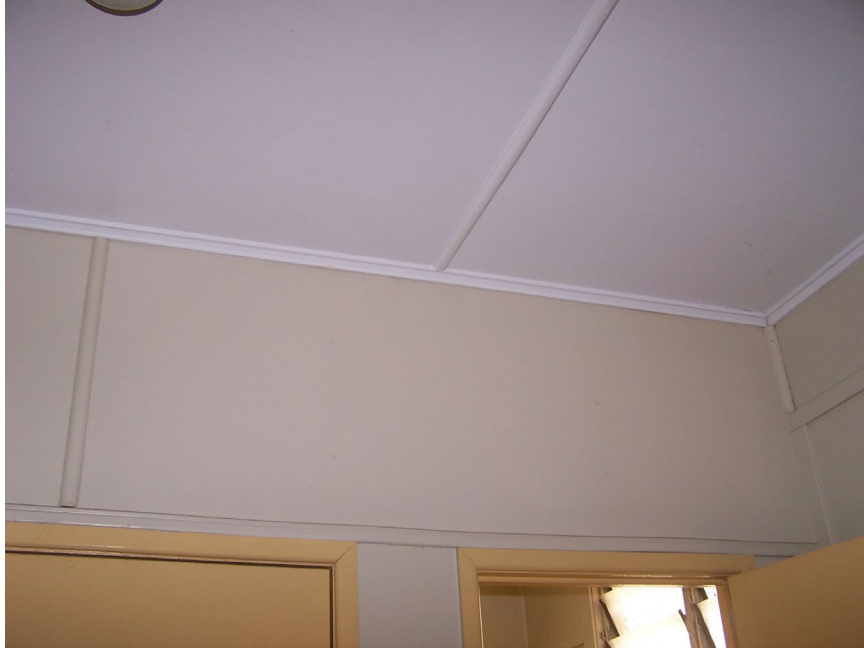
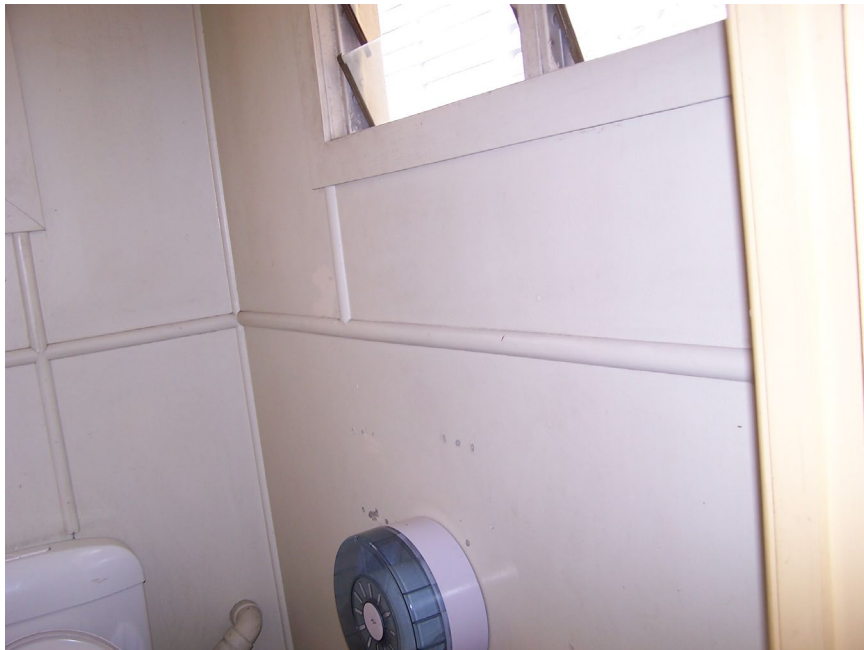
**Photo No: 87**

| Asbestos Containing Materials Register | | | | | | | | | | | | No Asbestos Detected | | | Areas with no Access | | |
|--|---|---|---|---|---|---|---|---|---|---|---|---|---|---|---|---|---|
| | Common Area Toilets | Ceiling & Wall Lining | P | 50 | sm | A/C Sheet | P | B | G | R | R | X | | | 87,88 | | |

**Common Area Toilets  
– Ceiling & Wall Lining**

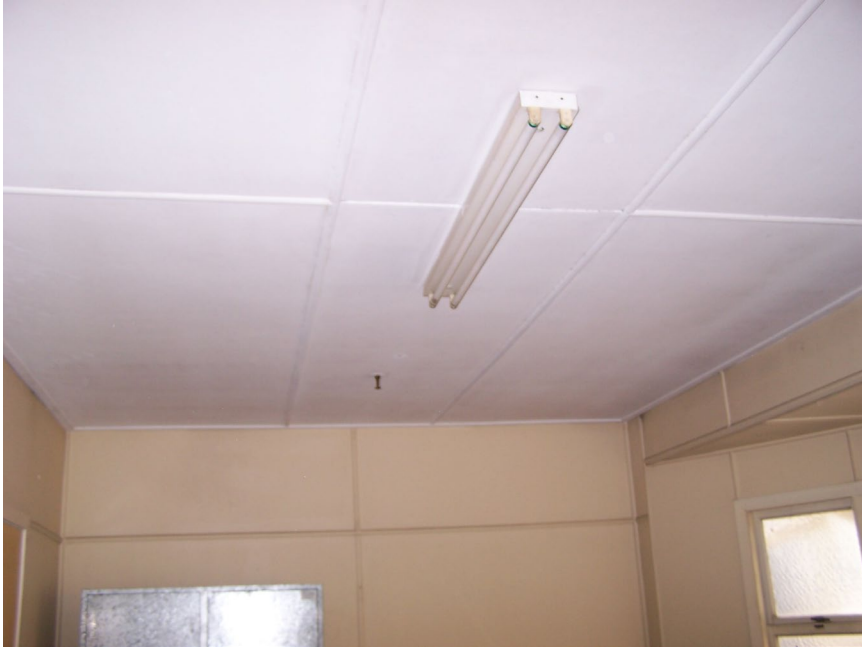
**Photo No: 89**

| Asbestos Containing Materials Register | | | | | | | | | | | | No Asbestos Detected | | | Areas with no Access | | |
|--|---|---|---|---|---|---|---|---|---|---|---|---|---|---|---|---|---|
| | Common Area Lunchroom | Ceiling & Wall Lining | P | 50 | sm | A/C Sheet | P | B | G | R | R | X | | | 89 | | |

**Common Area Lunchroom  
– Ceiling & Wall Lining**

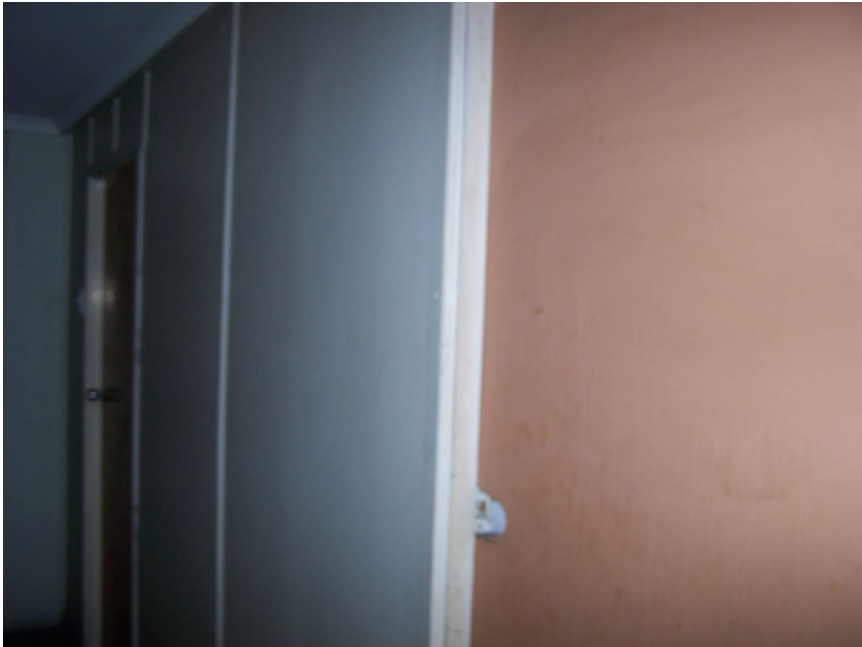
**Photo No: 90**

| Asbestos Containing Materials Register | | | | | | | | | | | | No Asbestos Detected | | | Areas with no Access | | |
|--|---|---|---|---|---|---|---|---|---|---|---|---|---|---|---|---|---|
| | Ladies Toilet | Ceiling & Wall Lining | P | | | A/C Sheet | P | B | G | R | R | X | | | 90 | | |

**Ladies Toilets – Ceiling & Wall Lining**

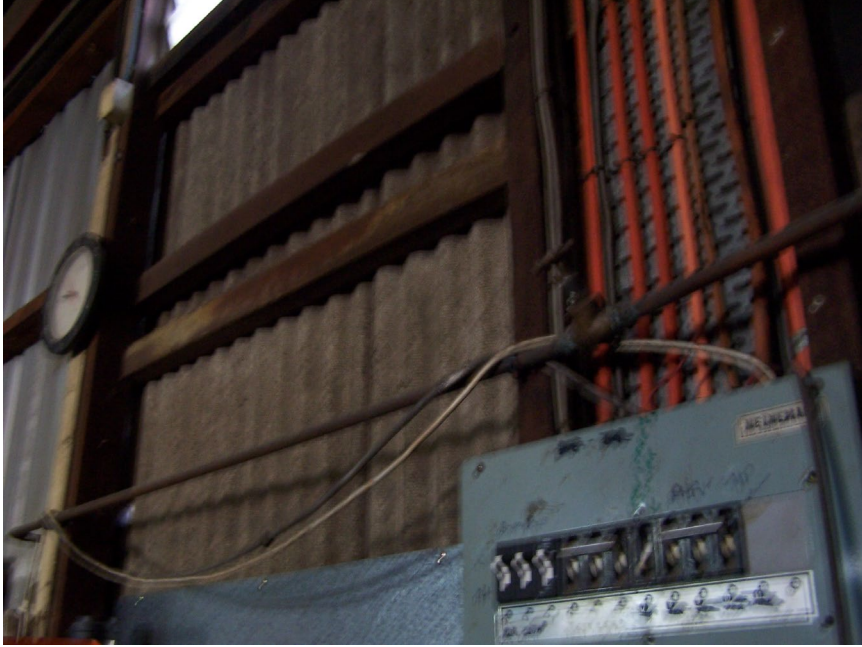
**Photo No: 93**

| Asbestos Containing Materials Register | | | | | | | | | | | | No Asbestos Detected | | | Areas with no Access | | |
|--|---|---|---|---|---|---|---|---|---|---|---|---|---|---|---|---|---|
| | Unit 10 Rear Wall | Wall Lining | P | 30 | sm | Mini Orb / A/C Sheet | P | B | F | R | R | X | | | 93 | | |

**Unit 10 Rear Wall – Wall Lining**

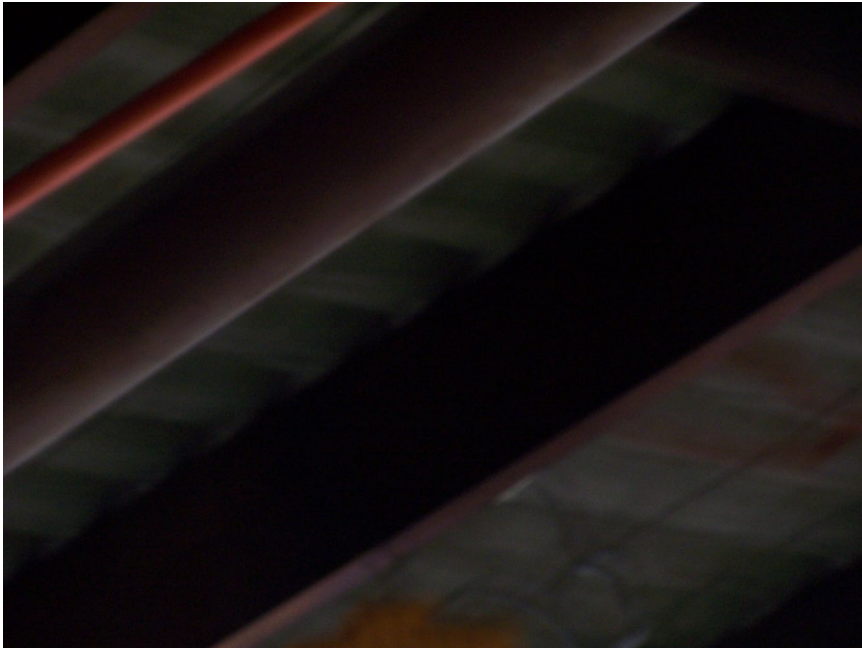
**Photo No: 98**

| Asbestos Containing Materials Register | | | | | | | | | | | | No Asbestos Detected | | | Areas with no Access | | |
|--|---|---|---|---|---|---|---|---|---|---|---|---|---|---|---|---|---|
| | Unit 13 Dexter St Building | Roofing | RS | 200 | sm | Super Six | P | B | G | R | R | X | E | | 98 | | Consider reroof |

**Unit 13 Roof**

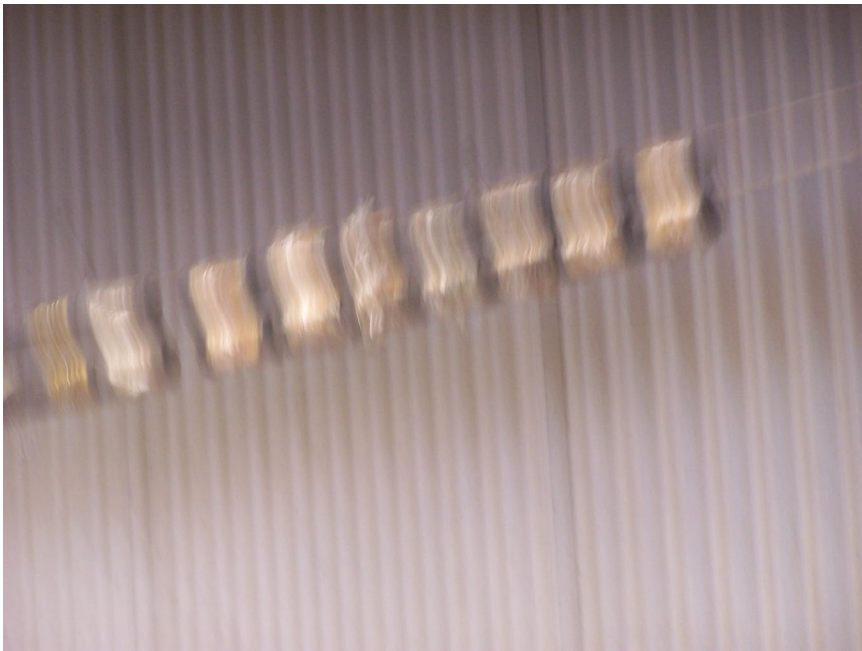
| Asbestos Containing Materials Register | | | | | | | | | | | | No Asbestos Detected | | | Areas with no Access | | |
|--|---|---|---|---|---|---|---|---|---|---|---|---|---|---|---|---|---|
| | Unit 13 Dexter St Building | Cladding | P | 36 | sm | Mini Orb | P | B | G | R | R | X | | | 97 | | |

**Photo No: 97      Unit 13 Cladding**

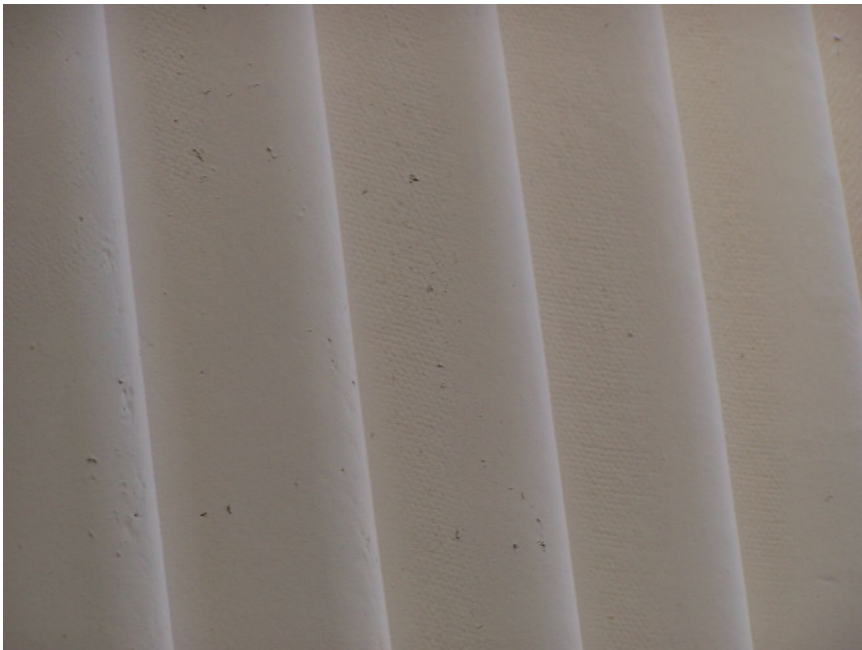
| Asbestos Containing Materials Register | | | | | | | | | | | | No Asbestos Detected | | | Areas with no Access | | |
|--|---|---|---|---|---|---|---|---|---|---|---|---|---|---|---|---|---|
| | Unit 13 Exterior Rear | Cladding | P | 36 | sm | Super Six | P | B | G | R | R | X | | | 102 | | |

**Photo No: 102      Exterior – Cladding**

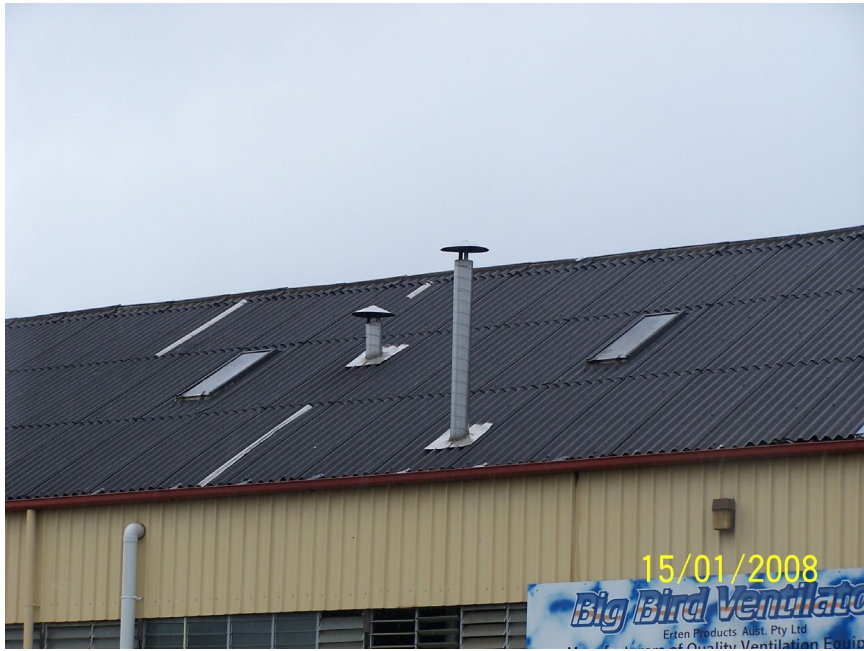
Photo No: 223

| Lvl | Location | Component | Surface Treatment | Material Extent | Material Unit | Form | Type | State | Condition | Activity Frequency | Likelihood of Disturbance | Advise | Action | Action Date | Photo No: | Sample No: | Comment |
|---|---|---|---|---|---|---|---|---|---|---|---|---|---|---|---|---|---|
| | Roof | Roofing | RS | 600 | sm | Super Six | P | B | F | R | R | X | E | 48 | 223 | | Consider reroof |
| | Roof | Ridge | RS | 70 | sm | Formed A/C Sheet | P | B | F | R | R | X | E | 48 | 223 | | Consider reroof |

Roof – Roofing & Ridge

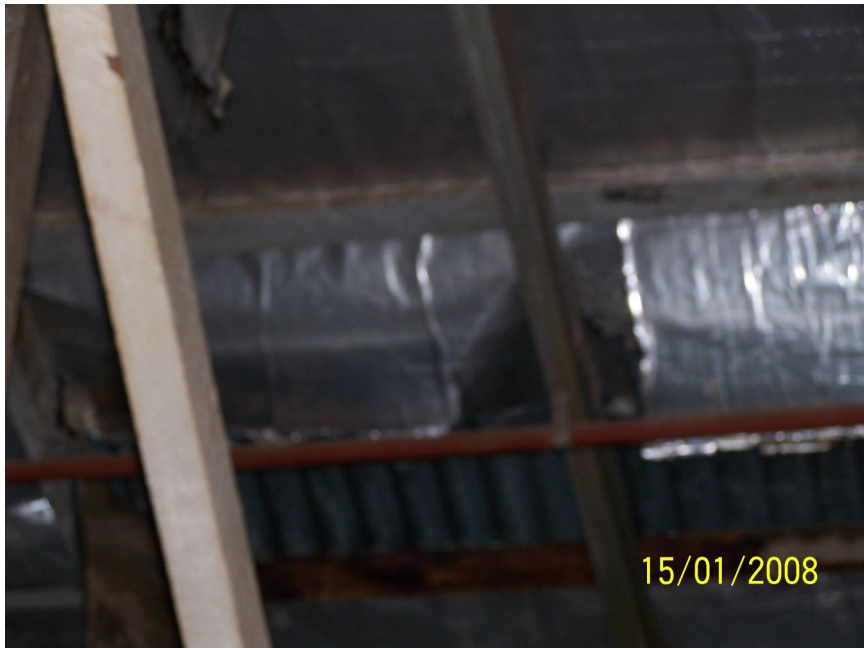
Photo No: 224

| Lvl | Location | Component | Surface Treatment | Material Extent | Material Unit | Form | Type | State | Condition | Activity Frequency | Likelihood of Disturbance | Advise | Action | Action Date | Photo No: | Sample No: | Comment |
|---|---|---|---|---|---|---|---|---|---|---|---|---|---|---|---|---|---|
| | Roof 15A | Insulation | P | | | Builders Paper | P | B | F | R | R | X | R | ASAP | 224 | | Consider reroof |

Roof – Insulation

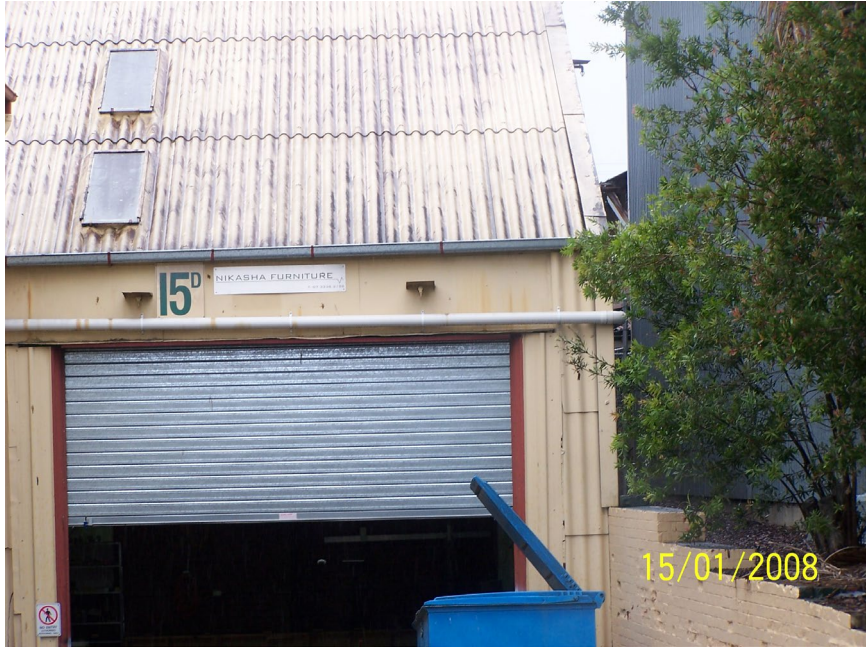
**Photo No: 225**

| Lvl | Location | Component | Surface Treatment | Material Extent | Material Unit | Form | Type | State | Condition | Activity Frequency | Likelihood of Disturbance | Advise | Action | Action Date | Photo No: | Sample No: | Comment |
|---|---|---|---|---|---|---|---|---|---|---|---|---|---|---|---|---|---|
| | Unit 15D | Cladding | P | | | Super Six | P | B | G | R | R | X | | | 225 | | |

**Unit 15 D – Cladding**

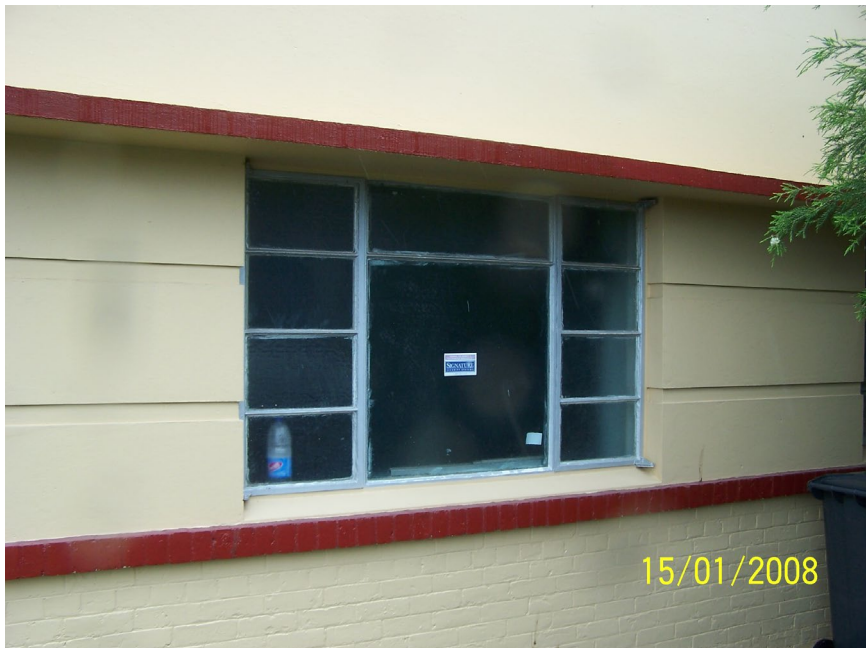
**Photo No: 228**

| Lvl | Location | Component | Surface Treatment | Material Extent | Material Unit | Form | Type | State | Condition | Activity Frequency | Likelihood of Disturbance | Advise | Action | Action Date | Photo No: | Sample No: | Comment |
|---|---|---|---|---|---|---|---|---|---|---|---|---|---|---|---|---|---|
| | Unit 15C | Window Putty | RS | 5 | each | Suspected | P | B | G | R | R | X | | | 228 | | |

**Unit 15 C – Window Putty**

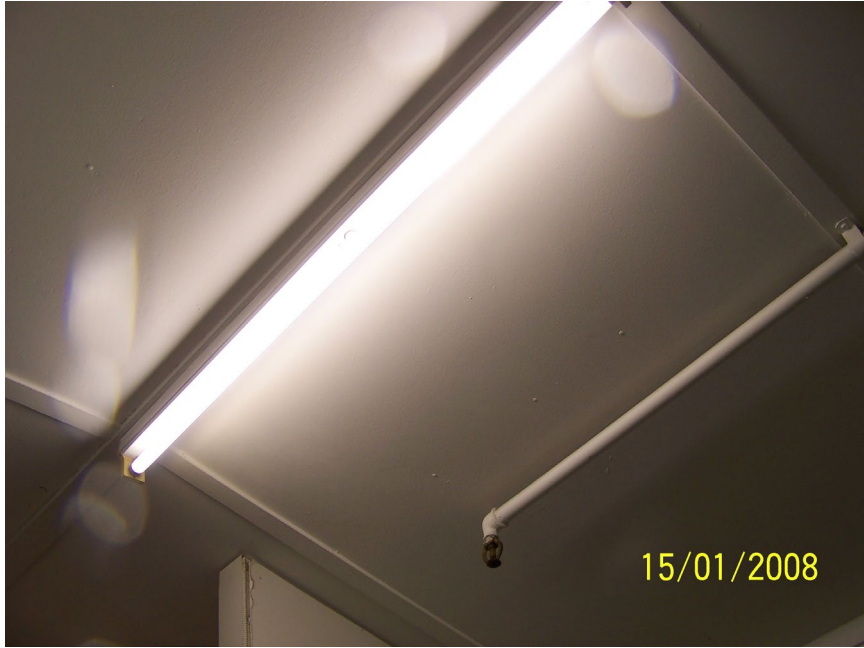
**Photo No: 229**

| Lvl | Location | Component | Surface Treatment | Material Extent | Material Unit | Form | Type | State | Condition | Activity Frequency | Likelihood of Disturbance | Advise | Action | Action Date | Photo No: | Sample No: | Comment |
|---|---|---|---|---|---|---|---|---|---|---|---|---|---|---|---|---|---|
| | Unit 15A Amenities | Ceiling Lining | P | 15 | sm | A/C Sheet | P | B | G | R | R | X | | | 229 | | |

**Unit 15 A  
- Ceiling Lining**

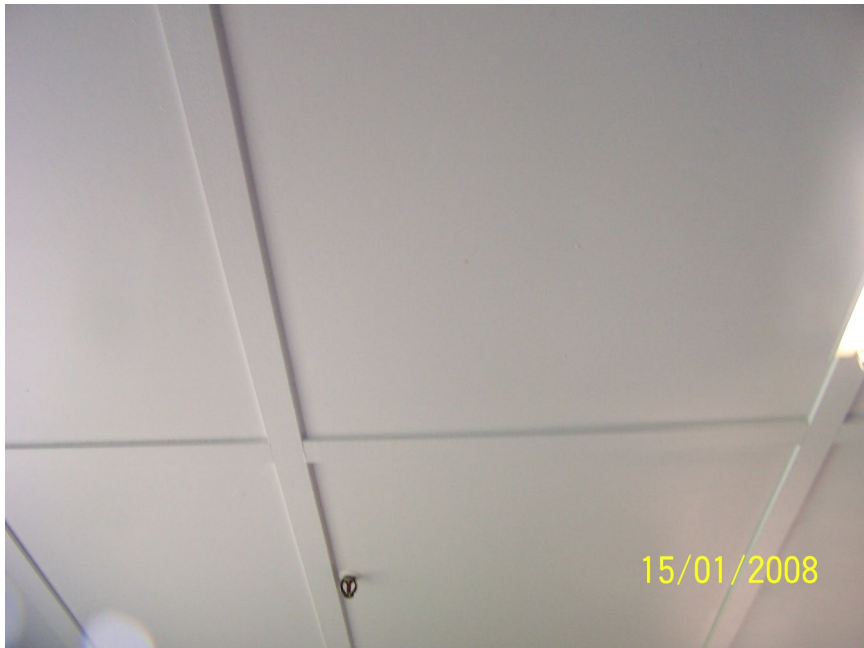
**Photo No: 230**

| Lvl | Location | Component | Surface Treatment | Material Extent | Material Unit | Form | Type | State | Condition | Activity Frequency | Likelihood of Disturbance | Advise | Action | Action Date | Photo No: | Sample No: | Comment |
|---|---|---|---|---|---|---|---|---|---|---|---|---|---|---|---|---|---|
| | Office 15A | Ceiling Lining | P | 12 | sm | A/C Sheet | P | B | G | R | R | X | | | 230 | | |

**Office - Ceiling Lining**

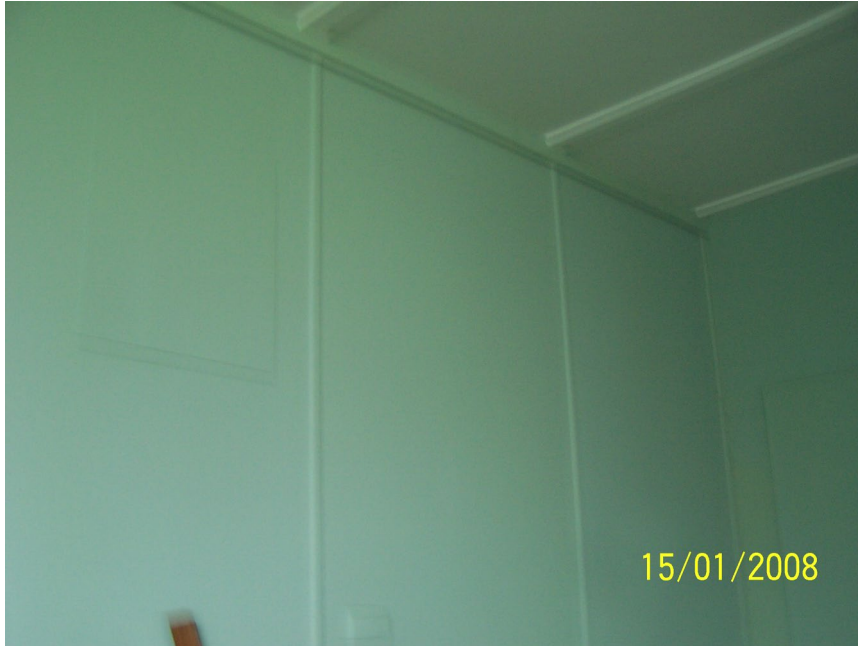
**Photo No: 231**

| Lvl | Location | Component | Surface Treatment | Material Extent | Material Unit | Form | Type | State | Condition | Activity Frequency | Likelihood of Disturbance | Advise | Action | Action Date | Photo No: | Sample No: | Comment |
|---|---|---|---|---|---|---|---|---|---|---|---|---|---|---|---|---|---|
| | Office 15A | Wall As Photographed | P | 9 | sm | A/C Sheet | P | B | G | R | R | X | | | 231 | | |

**Office – Wall As Photographed**

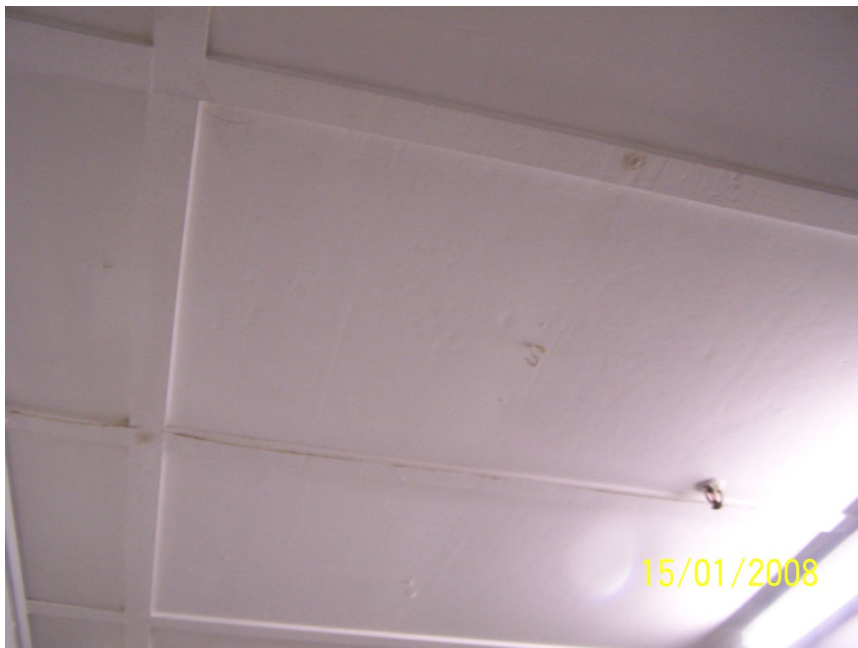
**Photo No: 232**

| Lvl | Location | Component | Surface Treatment | Material Extent | Material Unit | Form | Type | State | Condition | Activity Frequency | Likelihood of Disturbance | Advise | Action | Action Date | Photo No: | Sample No: | Comment |
|---|---|---|---|---|---|---|---|---|---|---|---|---|---|---|---|---|---|
| | Unit 15A Lunchroom | Ceiling Lining | P | 15 | sm | A/C Sheet | P | B | G | R | R | X | | | 232 | | |

**Unit 15 A Lunchroom – Ceiling Lining**

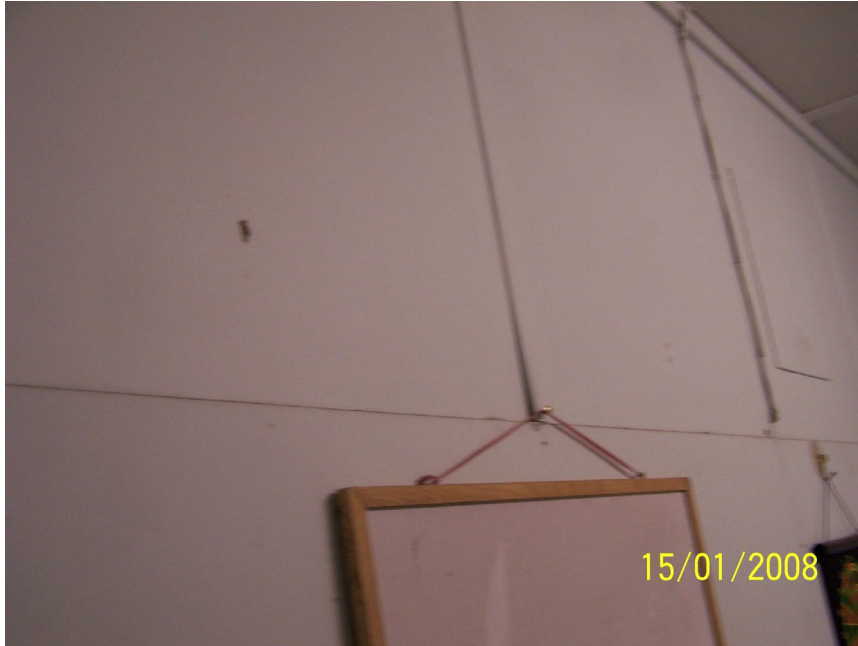
**Photo No: 233**

| Lvl | Location | Component | Surface Treatment | Material Extent | Material Unit | Form | Type | State | Condition | Activity Frequency | Likelihood of Disturbance | Advise | Action | Action Date | Photo No: | Sample No: | Comment |
|---|---|---|---|---|---|---|---|---|---|---|---|---|---|---|---|---|---|
| | Unit 15A Lunchroom | Wall As Photographed | P | | | A/C Sheet | P | B | G | R | R | X | | | 233 | | |

**Unit 15 A Lunchroom –  
Wall As Photographed**

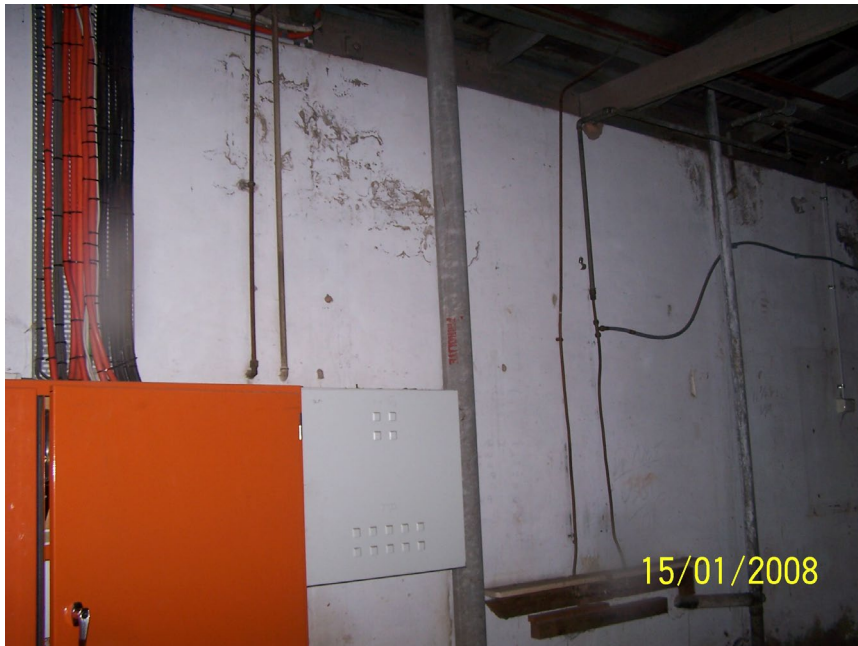
**Photo No: 234**

| Lvl | Location | Component | Surface Treatment | Material Extent | Material Unit | Form | Type | State | Condition | Activity Frequency | Likelihood of Disturbance | Advise | Action | Action Date | Photo No: | Sample No: | Comment |
|---|---|---|---|---|---|---|---|---|---|---|---|---|---|---|---|---|---|
| | Unit 15A Workshop | Vent Stack | RS | | | A/C Pipe | P | B | G | R | R | X | | | 234 | | |

**Unit 15 A Workshop – Vent Stack**

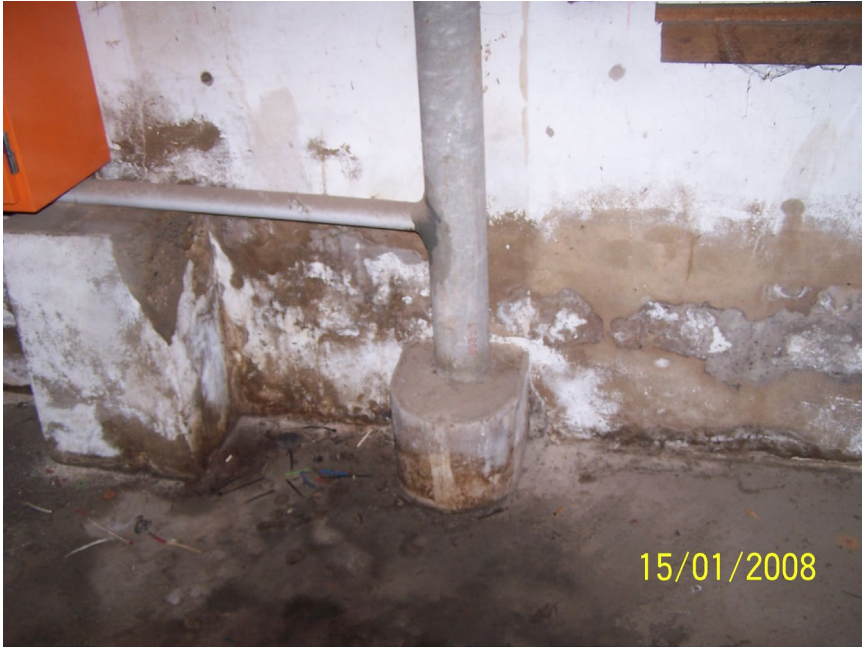
| Lvl | Location | Component | Surface Treatment | Material Extent | Material Unit | Form | Type | State | Condition | Activity Frequency | Likelihood of Disturbance | Advise | Action | Action Date | Photo No: | Sample No: | Comment |
|---|---|---|---|---|---|---|---|---|---|---|---|---|---|---|---|---|---|
| | Unit 15A Workshop | ORG Surround | RS | | | Formed A/C Sheet | P | B | F | R | R | X | | | 235 | | |

**Photo No: 235      Unit 15 A Workshop – Org Surround**
